Annual Inspection

Worplesdon Parish Council

White House Lane Play Area

Inspection Ref: 1207325

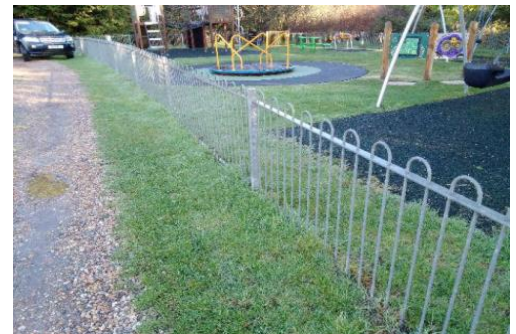
There is some damage to the fence sections - Monitor for any further deterioration and repair as required

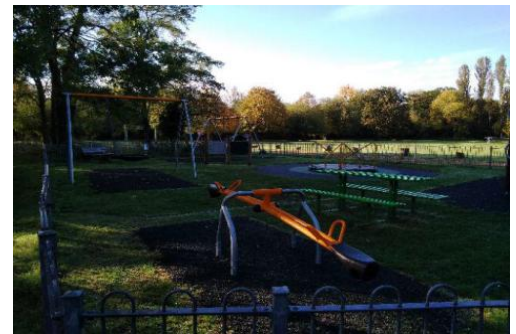
The site is accessible to the public during the COVID 19 pandemic. The government have released guidelines for safely re-opening these types of facilities which is available on the government website. - Ensure there is an appropriate risk assessment in place and review regularly

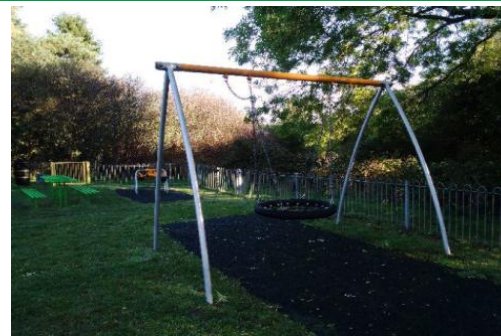
The surfacing dimensions are short and do not meet with the requirements of the current applicable standard - Monitor - no remedial action recommended

There are weeds/vegetation growth throughout the surfacing - Remove weeds/vegetation growth

The bushes are showing signs of wear - Monitor for any further deterioration and replace as required

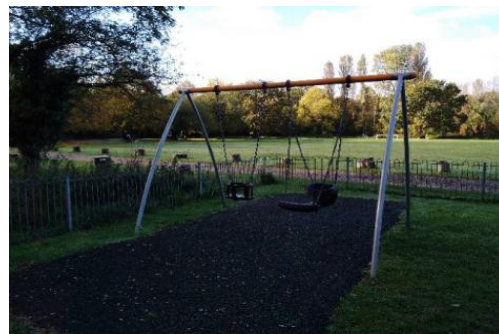
The surface has subsided in some areas - Monitor for any further deterioration and repair as required

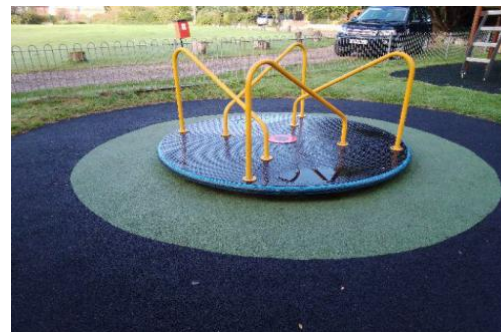
The surfacing around the item is damaged - Repair the damaged areas of surfacing

There are significant gaps (over 30mm) between the surface and the edging or between the joints in the surface; these are large enough for a small foot to enter - Repair surfacing

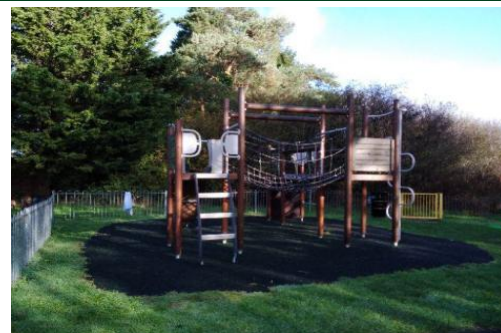
There are post / end caps missing from the item - Replace missing post caps

There are weeds/vegetation growth between or around the edges of the surfacing - Remove weeds/vegetation growth

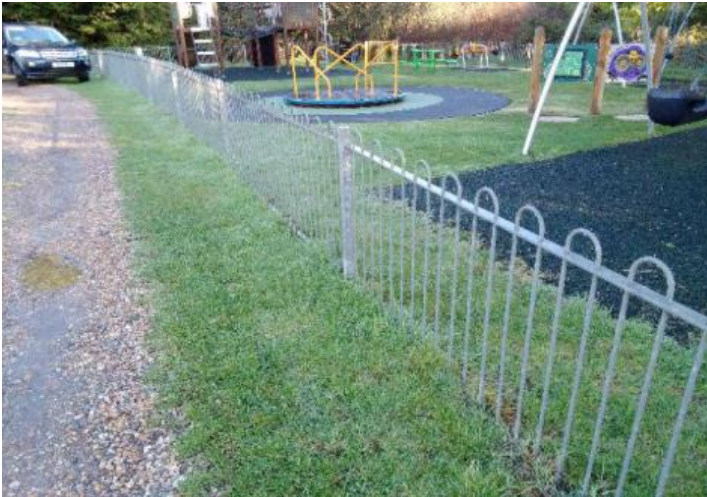
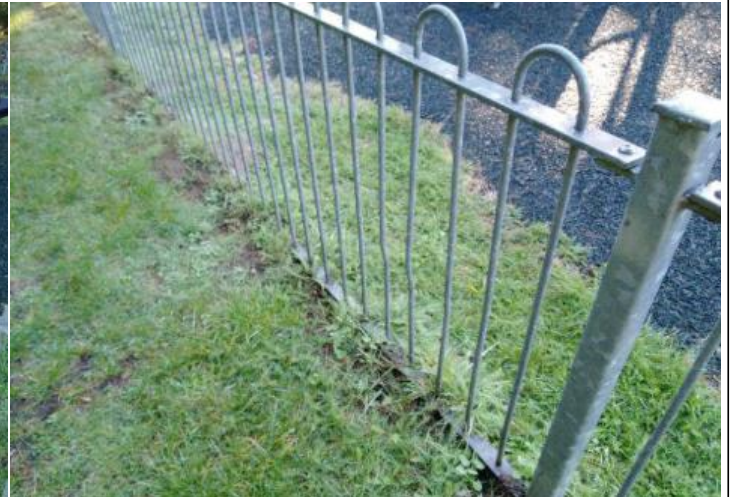
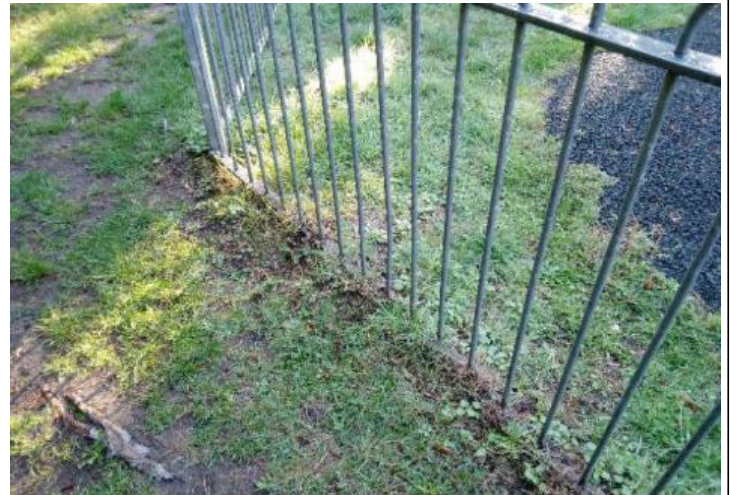
Item: Ancillary Items - Fence - Bow Top
Manufacturer: Owner/Operator

Finding: There is some damage to the fence sections

Action: Monitor for any further deterioration and repair as required

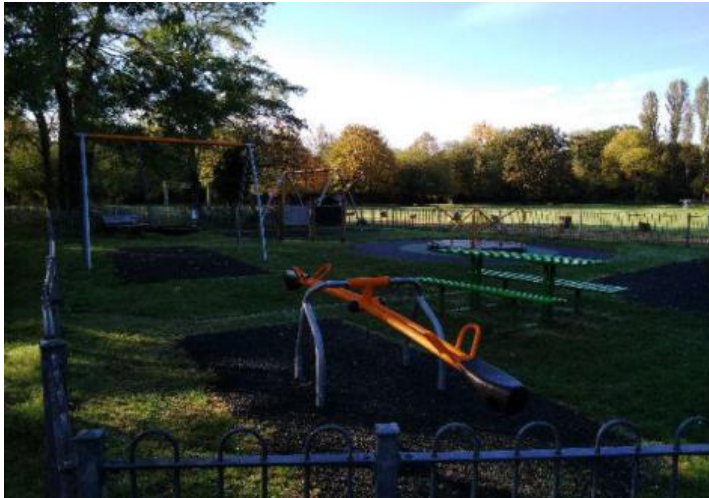
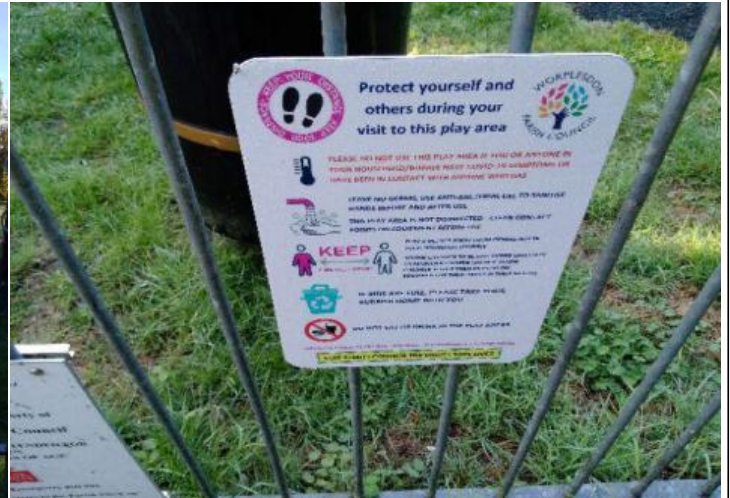
Item: Ancillary Items - Site General
Manufacturer: Owner/Operator

Finding: The site is accessible to the public during the COVID 19 pandemic. The government have released guidelines for safely re-opening these types of facilities which is available on the government website.

Action: Ensure there is an appropriate risk assessment in place and review regularly

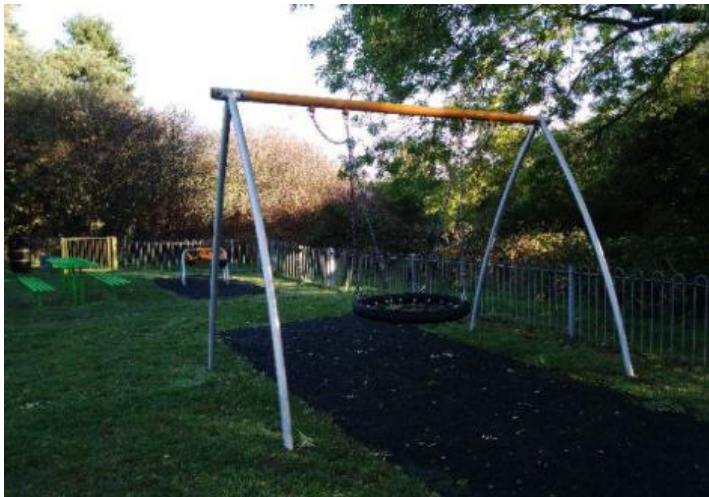
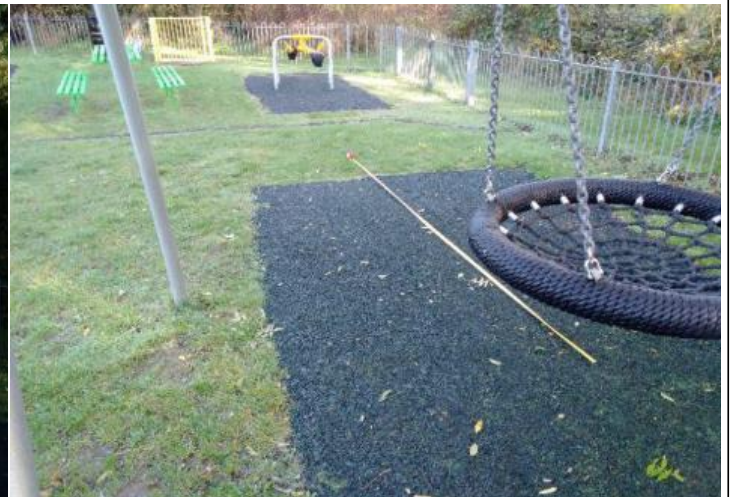
Item: Swings - Basket Swing - Type 1
Manufacturer: Hags

Finding: The surfacing dimensions are short and do not meet with the requirements of the current applicable standard

Action: Monitor - no remedial action recommended

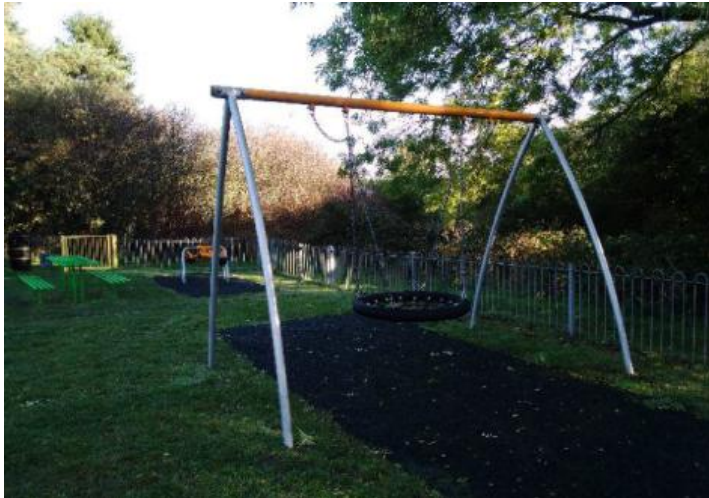
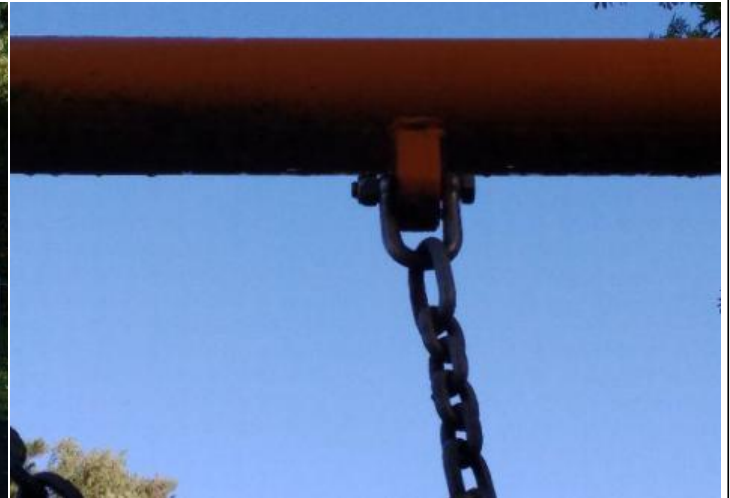
Item: Swings - Basket Swing - Type 1
Manufacturer: Hags

Finding: The bushes are showing signs of wear

Action: Monitor for any further deterioration and replace as required

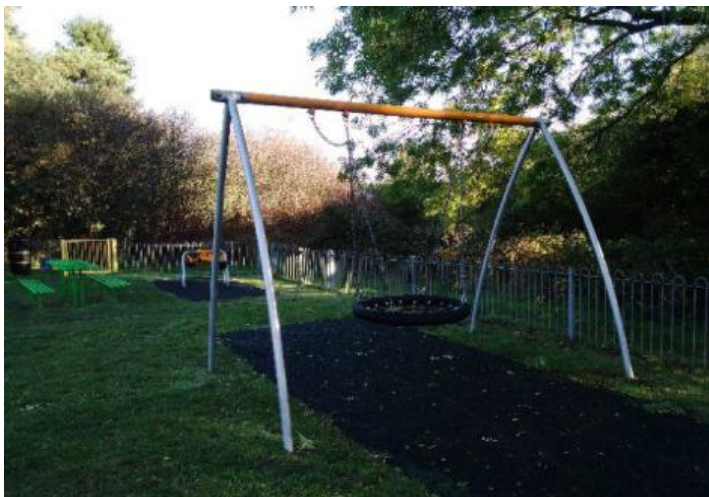
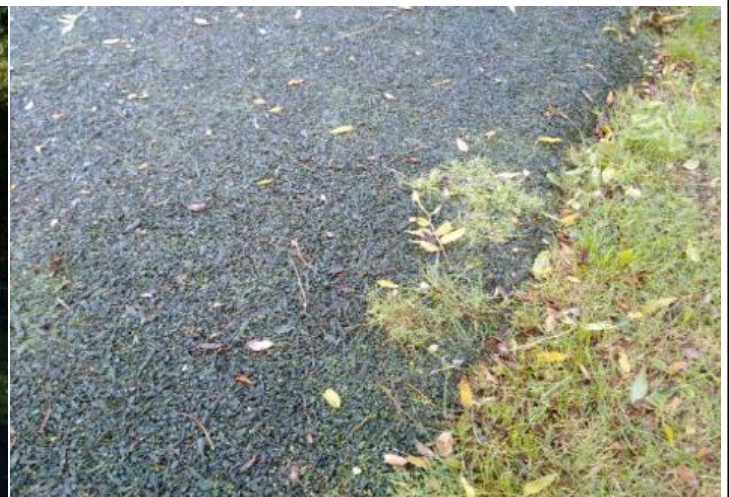
Item: Swings - Basket Swing - Type 1
Manufacturer: Hags

Finding: There are weeds/vegetation growth throughout the surfacing

Action: Remove weeds/vegetation growth

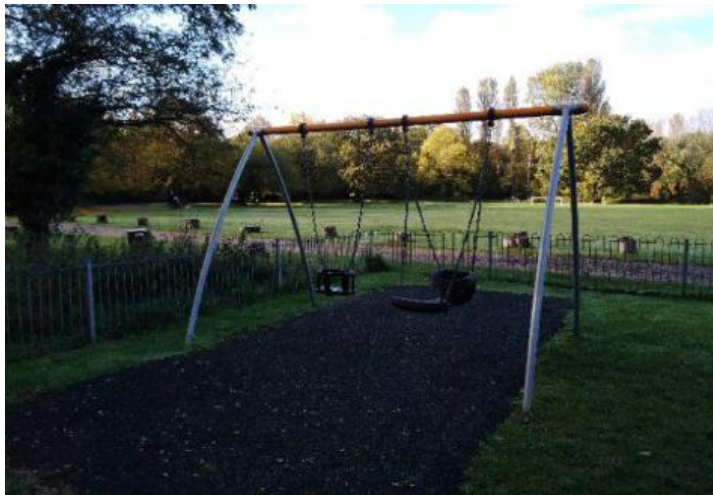
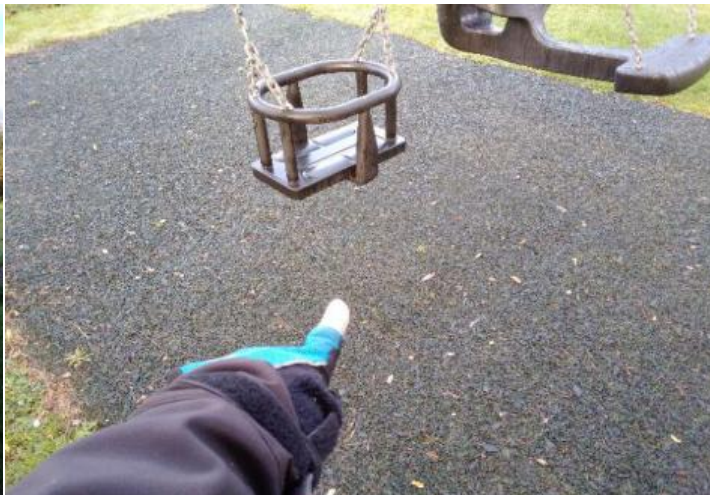
Item: Swings - 1 Bay Swing
Manufacturer: Hags

Finding: The surface has subsided in some areas

Action: Monitor for any further deterioration and repair as required

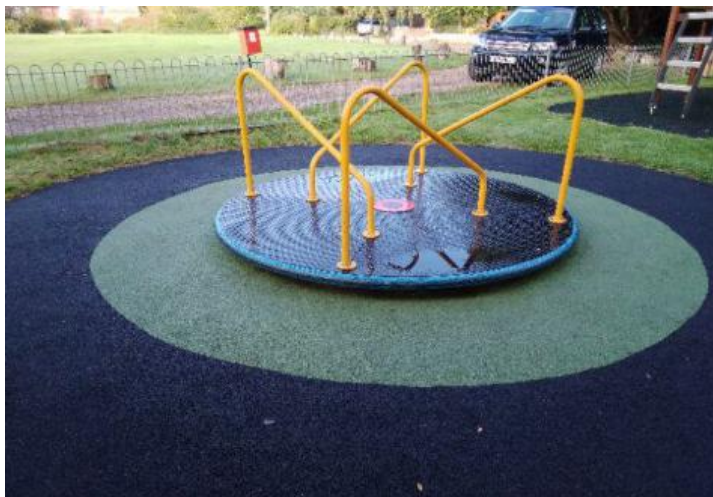
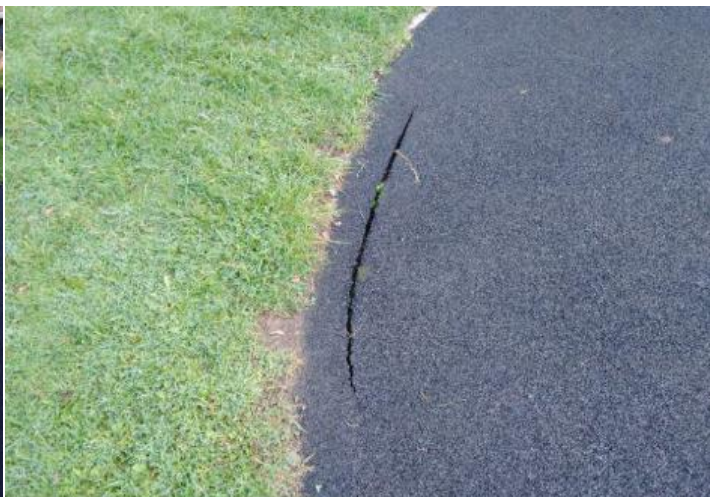
Item: Rotor Play - Roundabout
Manufacturer: Wicksteed Playgrounds

Finding: The surfacing around the item is damaged

Action: Repair the damaged areas of surfacing

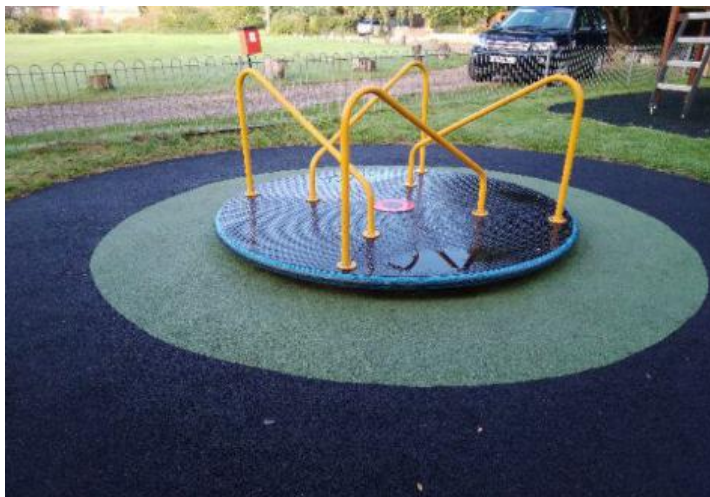
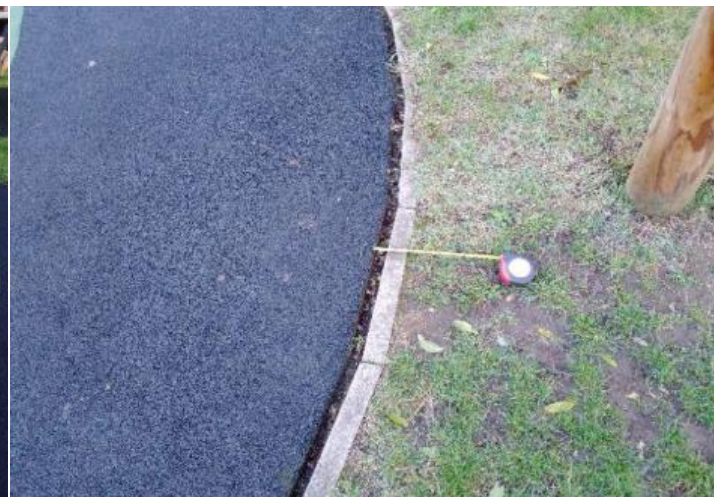
Item: Rotor Play - Roundabout
Manufacturer: Wicksteed Playgrounds

Finding: There are significant gaps (over 30mm) between the surface and the edging or between the joints in the surface; these are large enough for a small foot to enter

Action: Repair surfacing

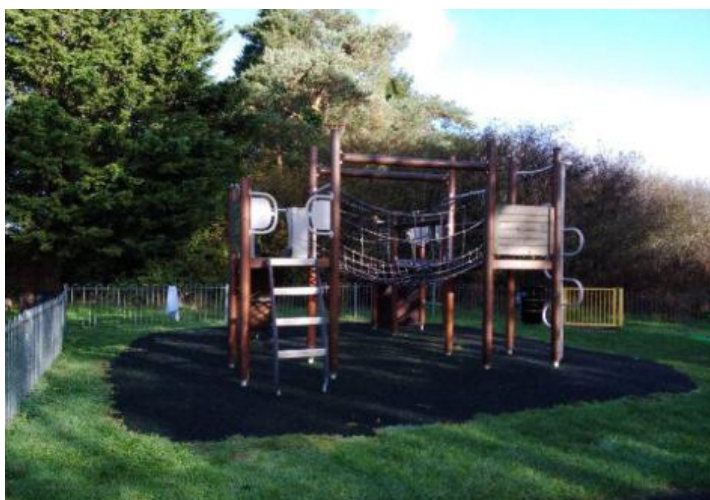
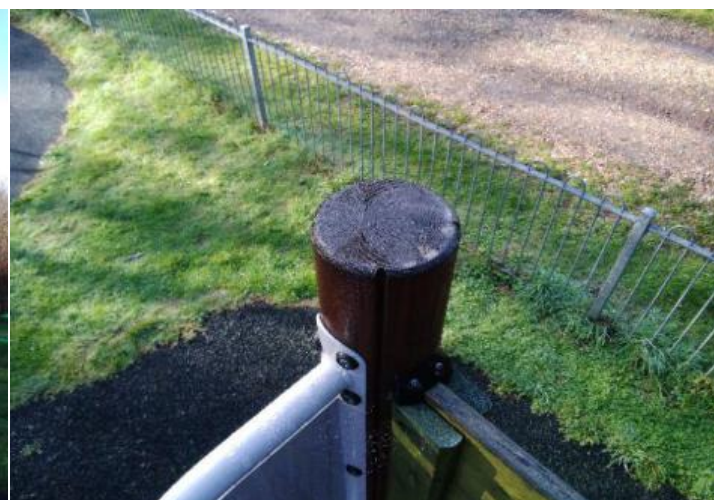
Item: Activity Equipment - Multi Play (Junior)
Manufacturer: Hags

Finding: There are post / end caps missing from the item

Action: Replace missing post caps

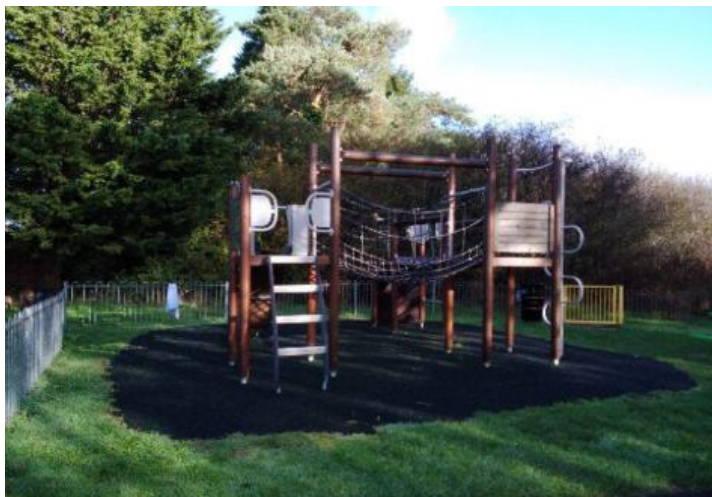
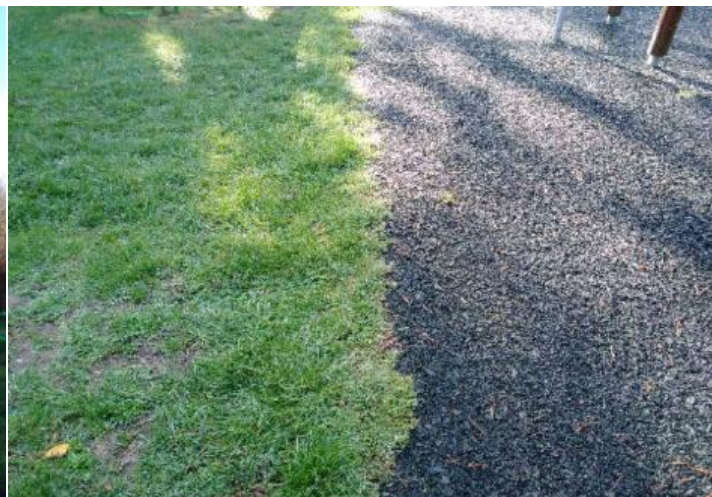
Item: Activity Equipment - Multi Play (Junior)
Manufacturer: Hags

Finding: There are weeds/vegetation growth between or around the edges of the surfacing

Action: Remove weeds/vegetation growth
