the **play inspection** company

Annual Inspection

Worplesdon Parish Council

Worplesdon Memorial Ground

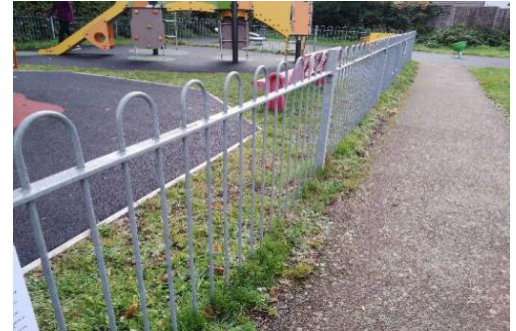
There is some damage to the fence sections - Monitor for any further deterioration and repair as required

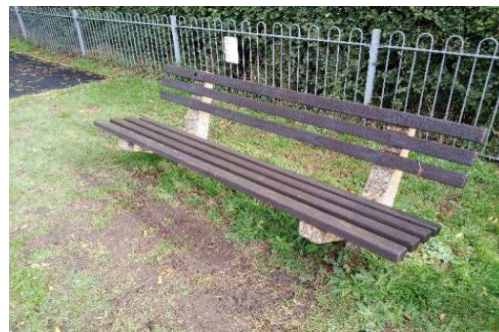
Parts of the timber are rough or splintered - Remove all rough or sharp edges

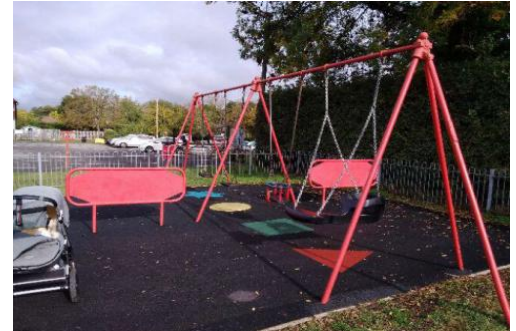
The bushes are showing signs of wear - Monitor for any further deterioration and replace as required

The chain openings are in excess of the 8.6mm as recommended by BS EN 1176 - Monitor - No remedial work recommended

There is some notable evidence of chain wear - Monitor for any further deterioration and replace when 40% worn

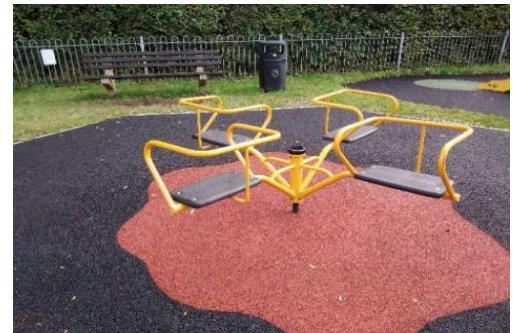
Parts of the steel structure protrude beyond the protected elements of the seat and fail to meet the requirements of BS EN 1176:2008 Part 5 - We consider this to be a low risk failure and no remedial action is required

The surface is lifting at the edges and creating trip points - Repair perimeter of surfacing to remove trip points

There are gaps opening between the surfacing and the edging surround or between the joints in the surfacing - Monitor for any further deterioration and repair as required

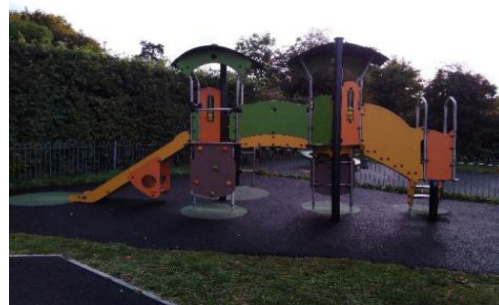
There is/are finger entrapment/s in the structure and the item fails to meet the requirements of BS EN 1176 Part 1 4.2.7.6
Entrapment of fingers - Monitor - No remedial work recommended

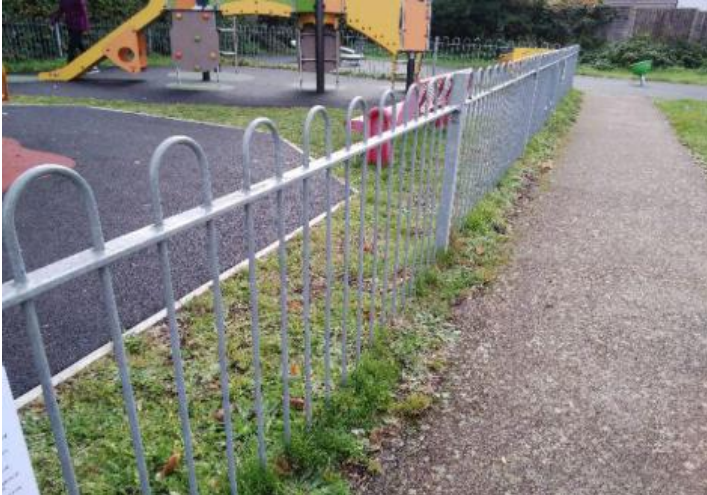
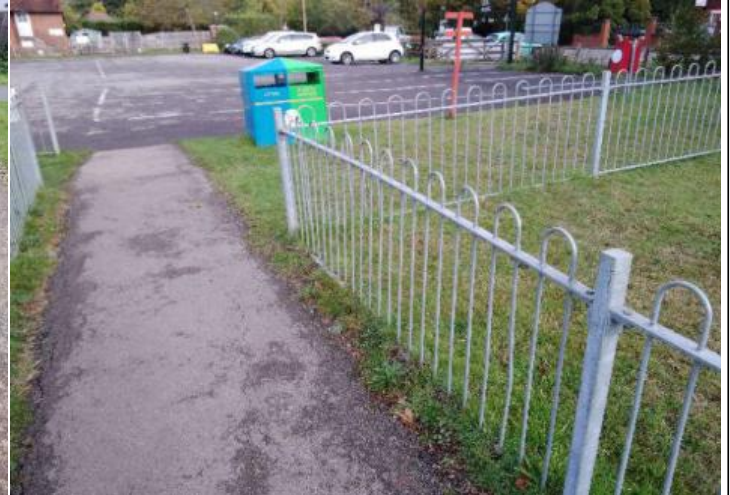
Finding: There is some damage to the fence sections

Action: Monitor for any further deterioration and repair as required

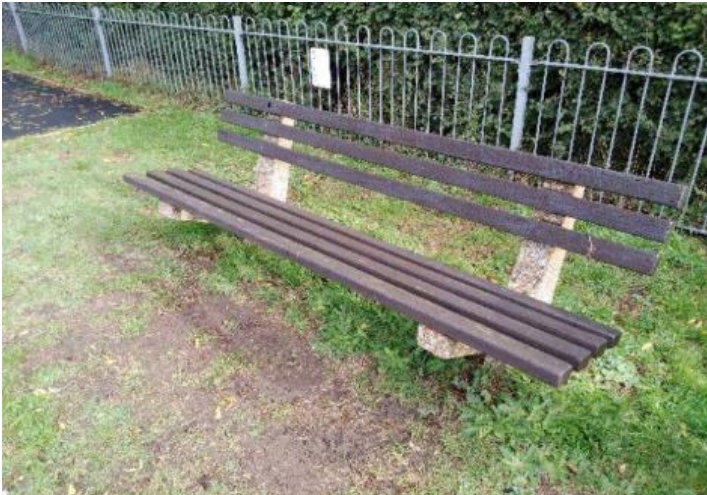
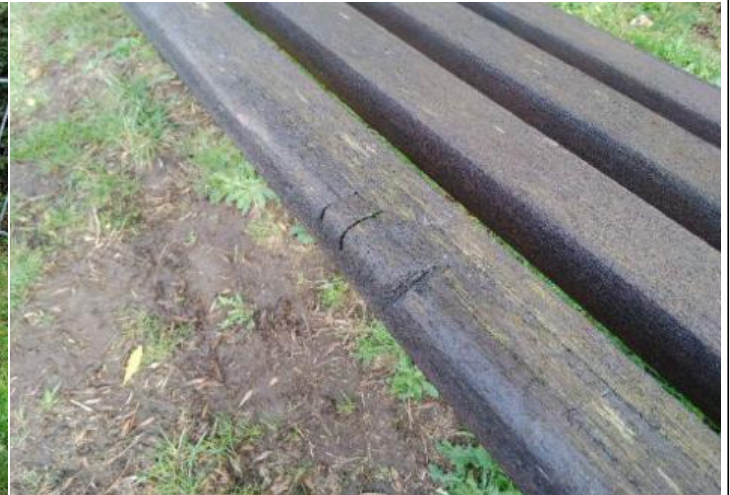
Finding: Parts of the timber are rough or splintered

Action: Remove all rough or sharp edges

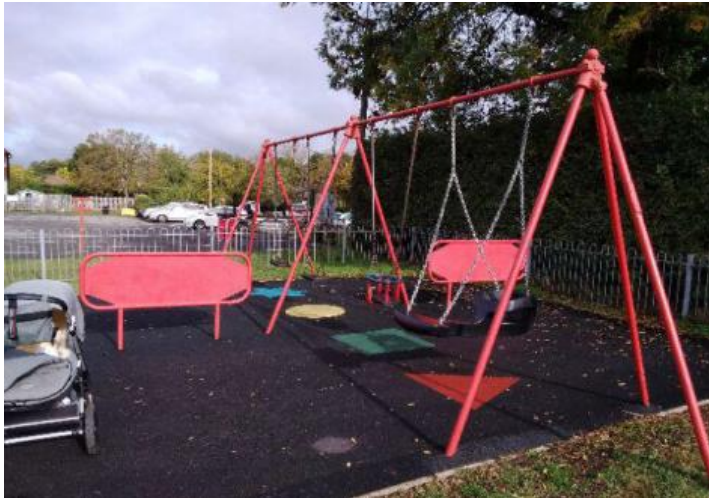
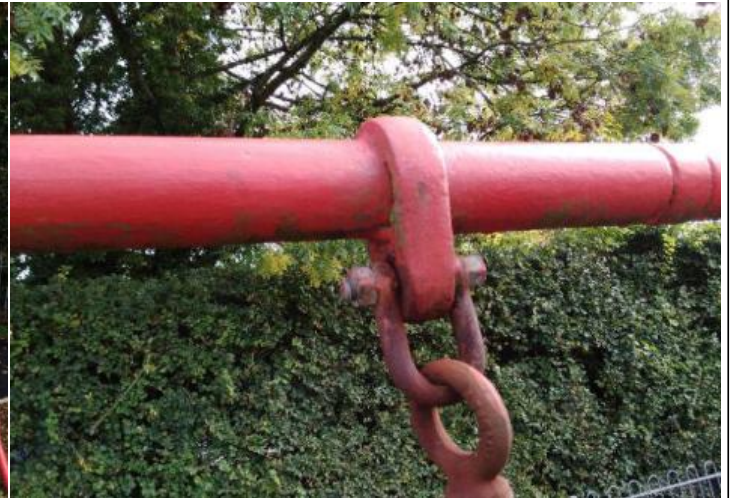
Finding: The bushes are showing signs of wear

Action: Monitor for any further deterioration and replace as required

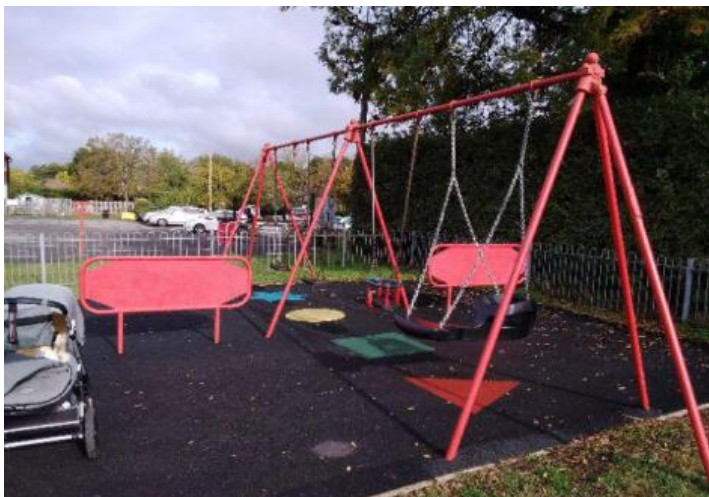
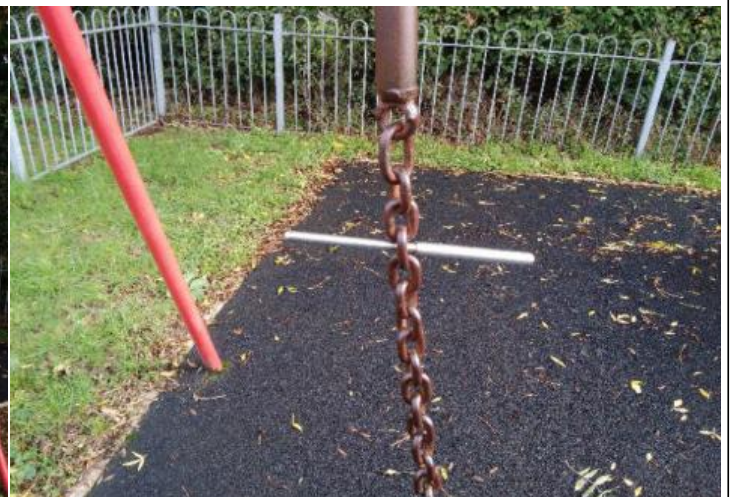
Finding: The chain openings are in excess of the 8.6mm as recommended by BS EN 1176

Action: Monitor - No remedial work recommended

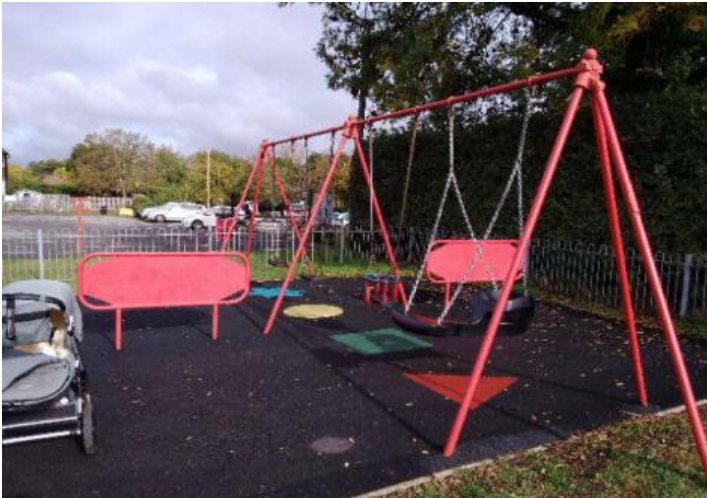
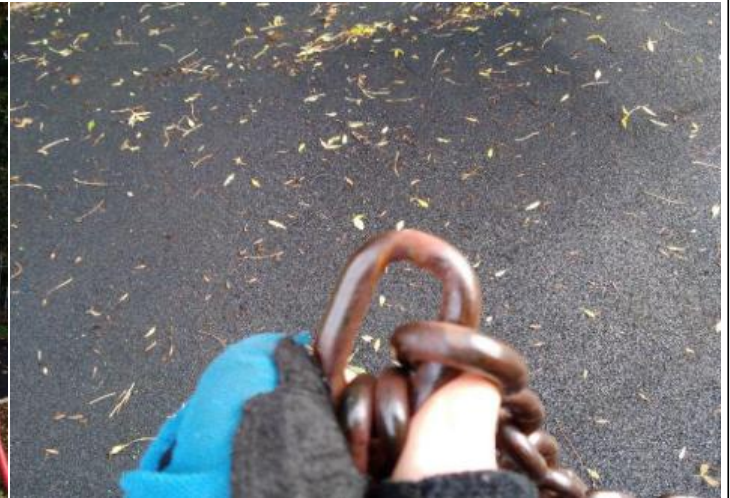
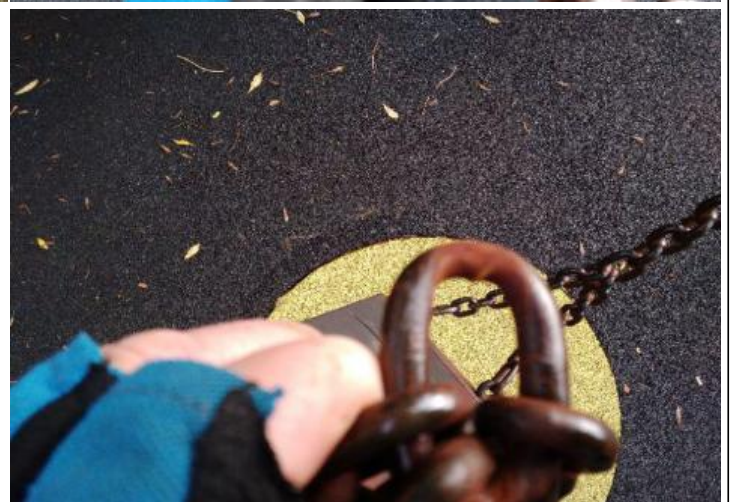
Finding: There is some notable evidence of chain wear

Action: Monitor for any further deterioration and replace when 40% worn

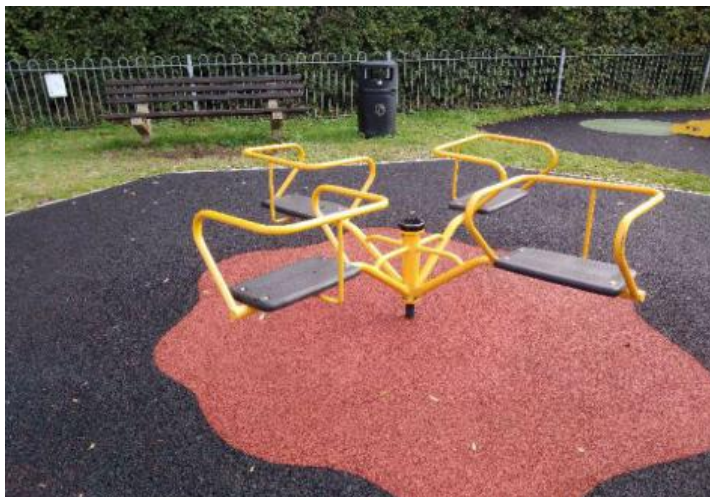
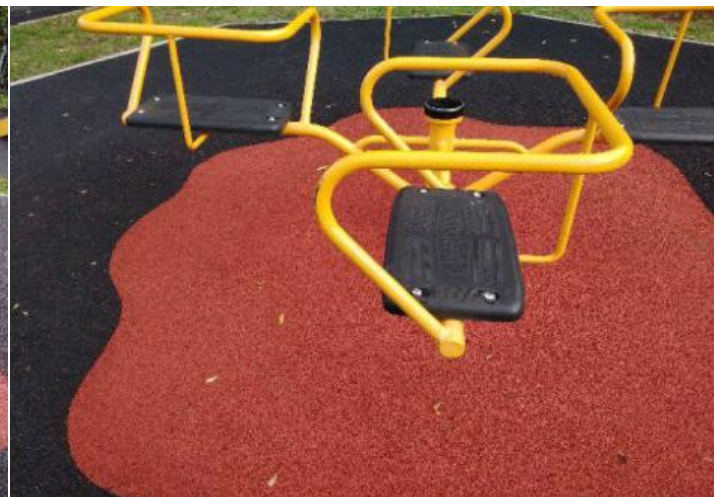
Finding: Parts of the steel structure protrude beyond the protected elements of the seat and fail to meet the requirements of BS EN 1176:2008 Part 5

Action: We consider this to be a low risk failure and no remedial action is required

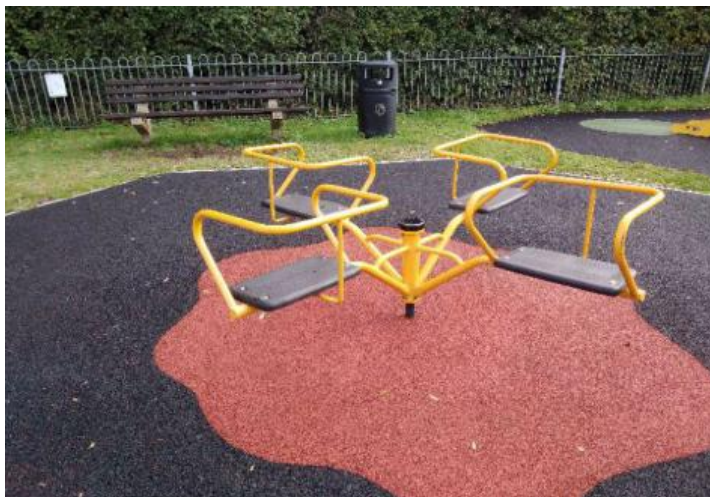
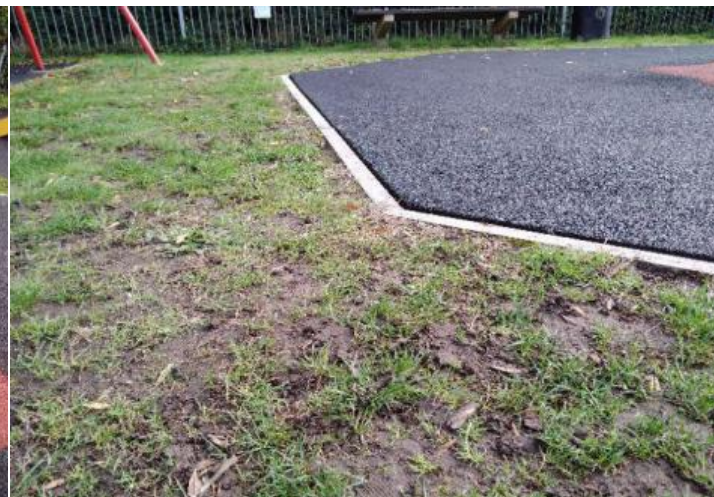
Finding: The surface is lifting at the edges and creating trip points

Action: Repair perimeter of surfacing to remove trip points

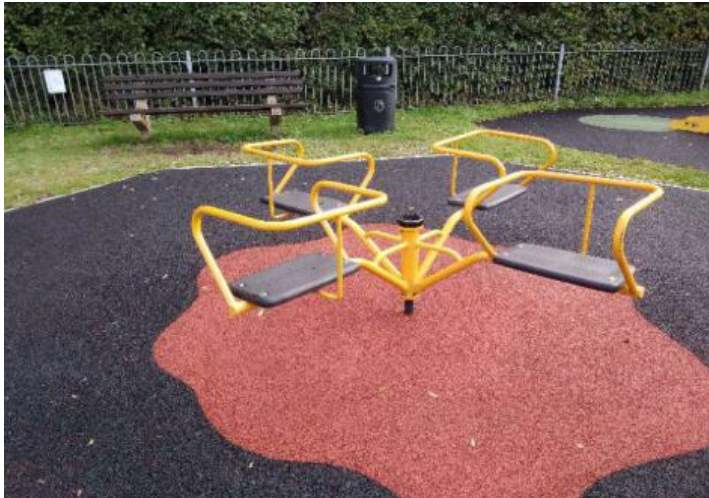
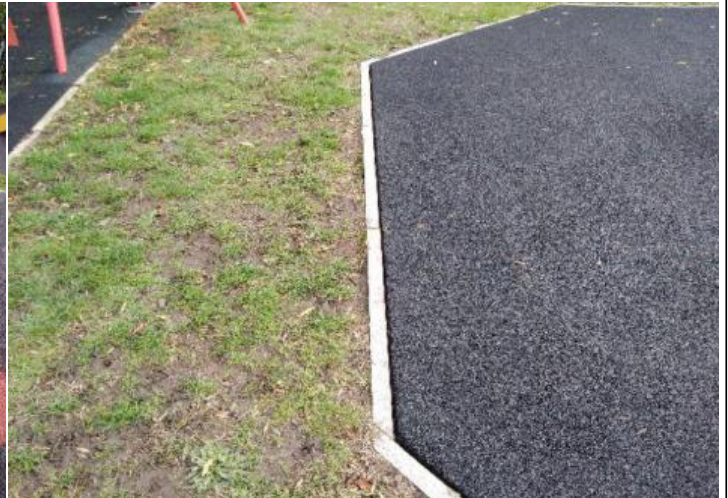
Finding: There are gaps opening between the surfacing and the edging surround or between the joints in the surfacing
Action: Monitor for any further deterioration and repair as required

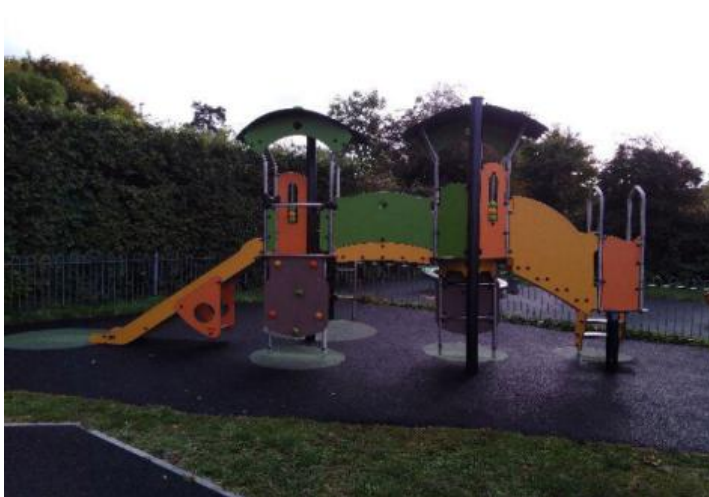
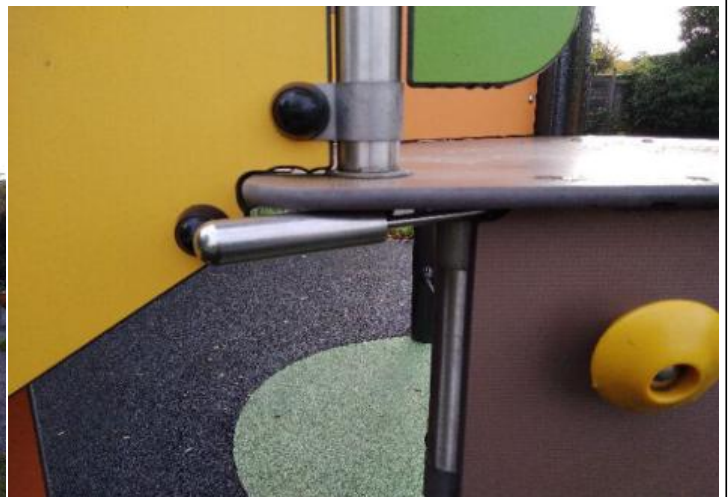
Finding: There is/are finger entrapment/s in the structure and the item fails to meet the requirements of BS EN 1176 Part 1 4.2.7.6 Entrapment of fingers

Action: Monitor - No remedial work recommended
