Annual Inspection

Worplesdon Parish Council

Worplesdon Memorial Ground - Teenage Area

Inspection Ref: 1207328 Site Ref: 4087 Customer Order: N/A

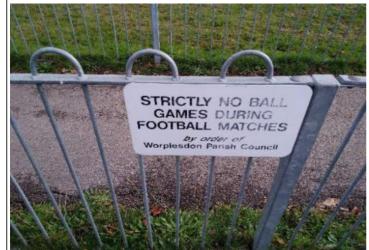
Item: Ancillary Items - Sign

Finding: BS EN 1176 Part 7 recommends that signage shall **Action:** Provide additional information include emergency contact details and contact details of owner / operator for reporting maintenance issues

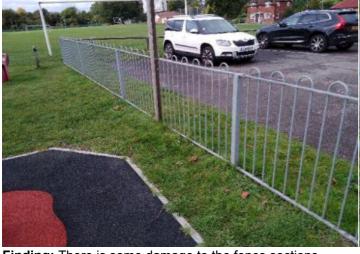
Item: Ancillary Items - Fence - Bow Top

There is some damage to the fence sections - Monitor for any further deterioration and repair as required

Action: Monitor for any further deterioration and repair as required

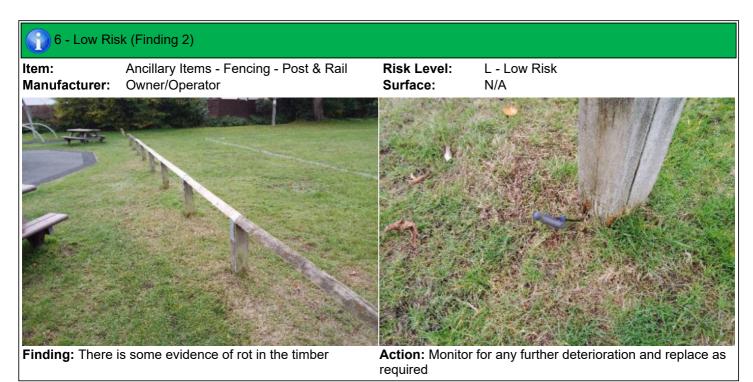
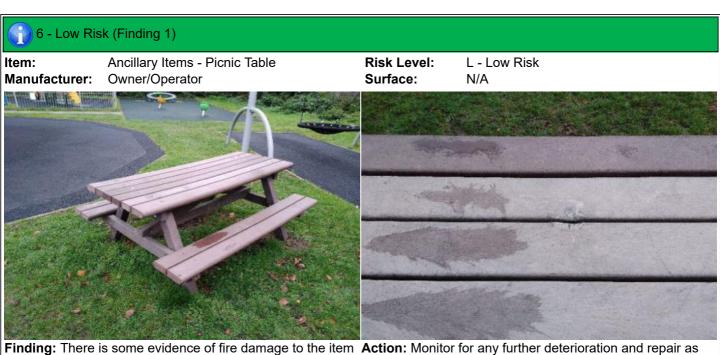
Item: Ancillary Items - Fencing - Post & Rail

There is some evidence of rot in the timber - Monitor for any

Finding: There is some strimmer / machinery damage apparent on the posts, this can penetrate the preservative applied to the timber and accelerate the rotting process

Action: Monitor for any deterioration (rot) and replace as required

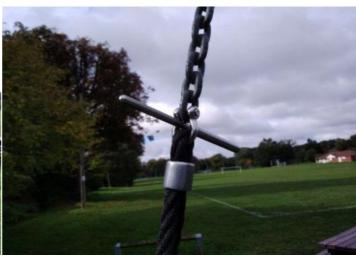
Swings - Basket Swing - Type 1 Item:

Finding: The connecting links are in excess of 8.6mm and Action: Monitor - No remedial work recommended less than 12mm and fail the requirements of BS EN 1176 Part 1; clause 4.2.13, Chains

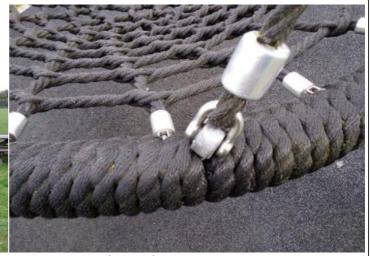
Item: Swings - Basket Swing - Type 1

Finding: The bushes are showing signs of wear

Action: Monitor for any further deterioration and replace as required

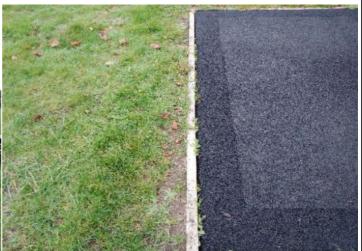
Item: Swings - Basket Swing - Type 1

Finding: There are gaps opening between the surfacing and Action: Monitor for any further deterioration and repair as the edging surround or between the joints in the surfacing required

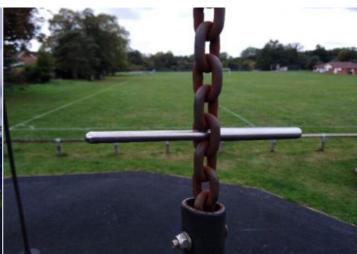
Item: Rotor Play - Typhoon Risk Level: V - Very Low Risk

Finding: The chain openings are in excess of the 8.6mm as **Action:** Monitor - No remedial work recommended recommended by BS EN 1176

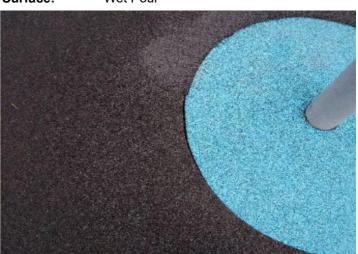
Item:Rotor Play - TyphoonRisk Level:V - Very Low RiskManufacturer:HagsSurface:Wet Pour

Finding: The safety surface under or around this unit has been damaged

Action: Monitor for any further deterioration and repair as required

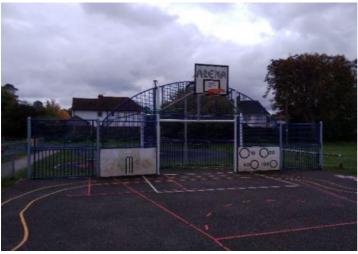
Multi Use Games Area - Goalmouth and
Basketball Post

Finding: There is/are finger entrapments in the mesh and the item fails to meet the requirements of BS EN 15312 Clause 4.4.2.2 Entrapment of fingers

Action: Monitor - No remedial work recommended

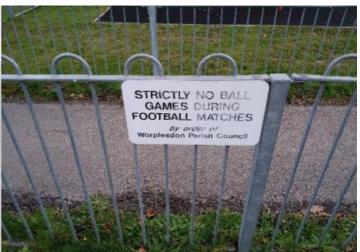
Multi Use Games Area - Goalmouth and Item: **Basketball Post**

Finding: A clearly visible facility sign should be provided in Action: Provide signage to BS EN 15312 a prominent position with the wording as detailed BS EN 15312- the equipment is not intended for children less than 3 years old- the warning - Do not climb on the framework or nets- the warning - Do not hang on the ring (if provided)- the warning - Do not wear rings or other jewellery- name and telephone number of the administrator- number to call in case of accident
