Annual Inspection

Worplesdon Parish Council

Wood Street

Village Green, Worplesdon, Guildford, Surrey, GU3 3EU

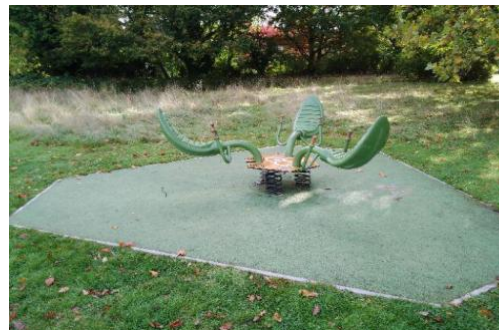
Finding 1

Item: Site General
Manufacturer: Owner/Operator
Surface Type: N/A
Item Quantity: 1
Equipment Compliance: N/A
Surface Area Compliance: N/A

It is recommended that information signs with emergency contact details are installed at each entrance/exit point to the playground - Provide in accordance with the recommendations set out in BS EN 1176

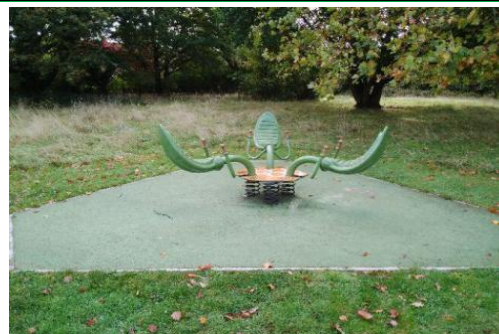
Finding 1

Item: Three Way Springer
Manufacturer: Husson UK
Surface Type: Wet Pour
Item Quantity: 1
Equipment Compliance: Yes
Surface Area Compliance: Yes
Life Expectancy: 5 -10 Years
Total Findings: 1

There is some damage to the item - Monitor use and repair as required

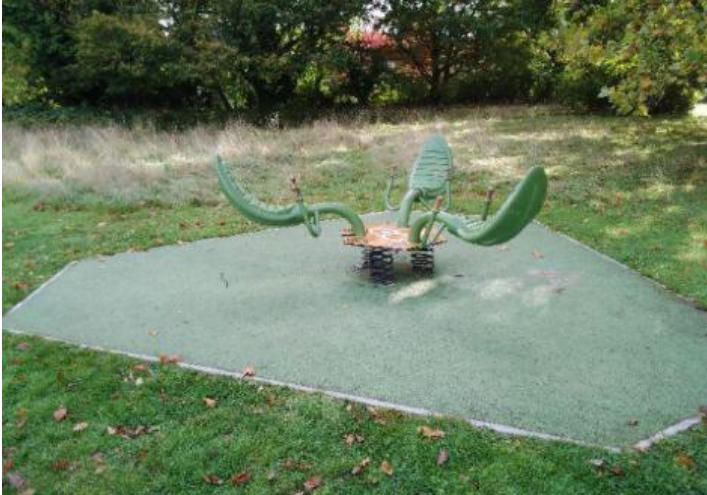
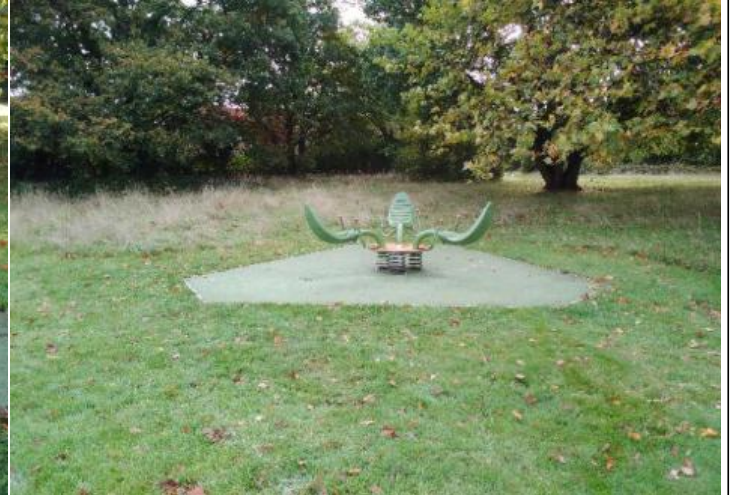
2 - Very Low Risk (Finding 1)

Item: Ancillary Items - Site General
Manufacturer: Owner/Operator

Risk Level: V - Very Low Risk
Surface: N/A

Finding: It is recommended that information signs with emergency contact details are installed at each entrance/exit point to the playground

Action: Provide in accordance with the recommendations set out in BS EN 1176

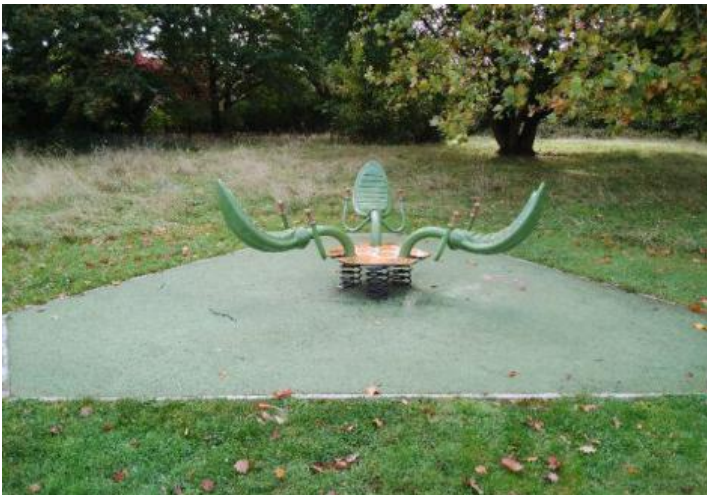
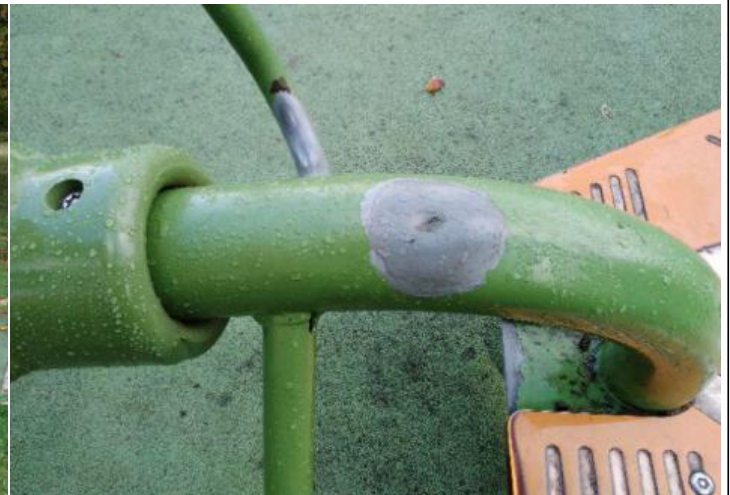
6 - Low Risk (Finding 1)

Item: Rocking Equipment - Three Way Springer
Manufacturer: Husson UK

Risk Level: L - Low Risk
Surface: Wet Pour

Finding: There is some damage to the item

Action: Monitor use and repair as required
