Annual Inspection

Worplesdon Parish Council

White House Lane Play Area

Inspection Ref: 1207325

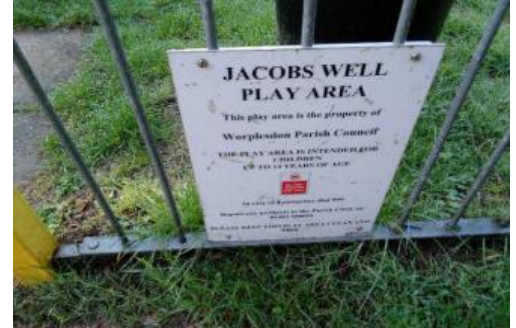
Finding 1

Item: Sign
Manufacturer: Owner/Operator
Surface Type: N/A
Item Quantity: 1
Equipment Compliance: N/A
Surface Area Compliance: N/A

This item is satisfactory - no work required -

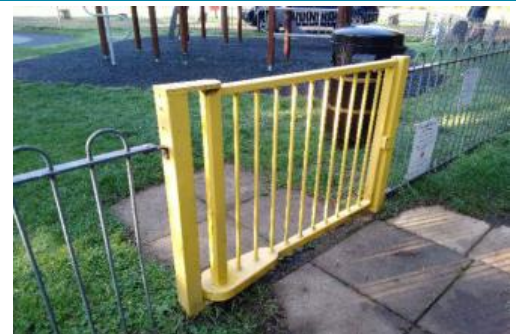
Finding 1

Item: Gate - Self Closing
Manufacturer: Owner/Operator
Surface Type: N/A
Item Quantity: 1
Equipment Compliance: N/A
Surface Area Compliance: N/A

This item is satisfactory - no work required -

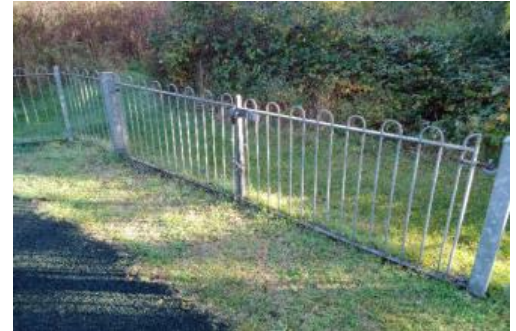
Finding 1

Item: Gate - Maintenance
Manufacturer: Owner/Operator
Surface Type: N/A
Item Quantity: 1
Equipment Compliance: N/A
Surface Area Compliance: N/A

This item is satisfactory - no work required -

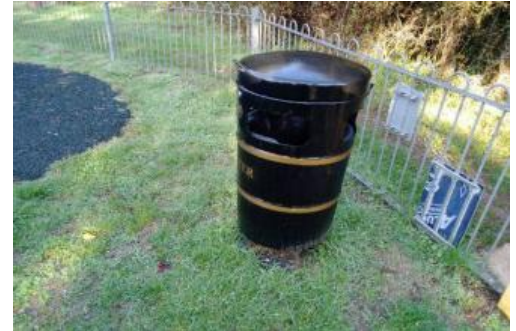
Finding 1

Item: Litter Bin
Manufacturer: Owner/Operator
Surface Type: N/A
Item Quantity: 1
Equipment Compliance: N/A
Surface Area Compliance: N/A

This item is satisfactory - no work required -

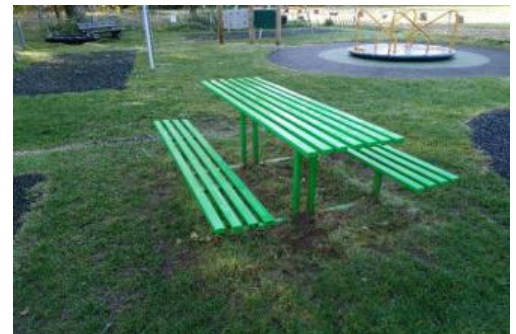
Finding 1

Item: Picnic Table
Manufacturer: Wicksteed Playgrounds
Surface Type: N/A
Item Quantity: 1
Equipment Compliance: N/A
Surface Area Compliance: N/A

This item is satisfactory - no work required -

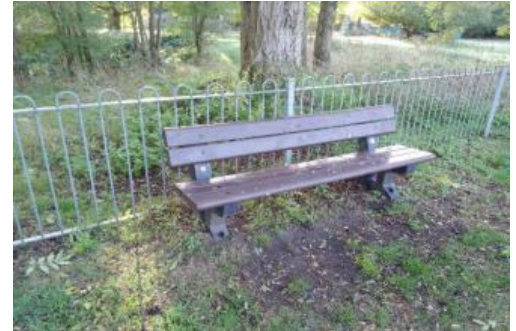
Finding 1

Item: Bench
Manufacturer: Owner/Operator
Surface Type: N/A
Item Quantity: 1
Equipment Compliance: N/A
Surface Area Compliance: N/A

This item is satisfactory - no work required -

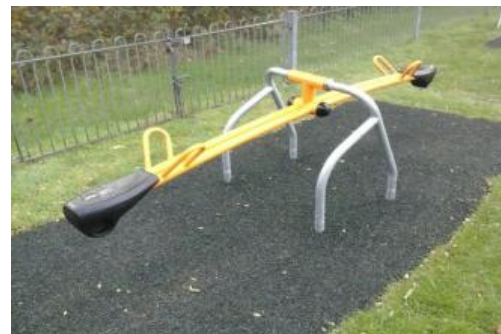
Finding 1

Item: See Saw
Manufacturer: Hags
Surface Type: Bonded Rubber Mulch
Item Quantity: 1
Equipment Compliance: Yes
Surface Area Compliance: Yes
Life Expectancy: 5 -10 Years
Total Findings: 1

This item is satisfactory - no work required -

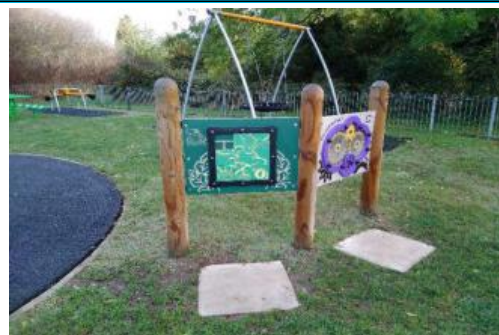
Finding 1

Item: Play Panel
Manufacturer: Unknown
Surface Type: Grass
Item Quantity: 2
Equipment Compliance: Yes
Surface Area Compliance: N/A
Life Expectancy: 5 -10 Years
Total Findings: 1

This item is satisfactory - no work required -
