the **play inspection** company

Annual Inspection

Worplesdon Parish Council

Worplesdon Memorial Ground

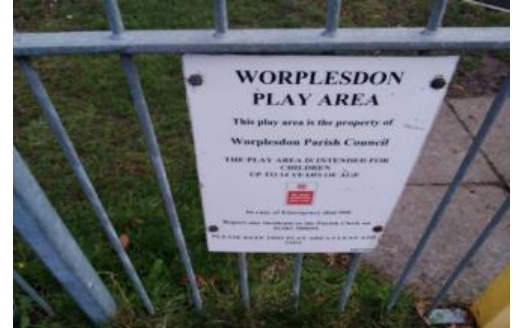
Item: Sign
Manufacturer: Owner/Operator
Surface Type: N/A
Item Quantity: 3
Equipment Compliance: N/A
Surface Area Compliance: N/A

This item is satisfactory - no work required -

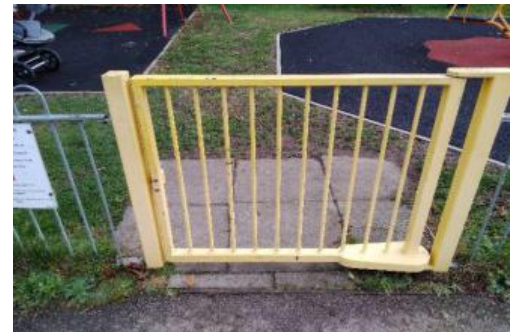
Item: Gate - Self Closing
Manufacturer: Owner/Operator
Surface Type: N/A
Item Quantity: 1
Equipment Compliance: N/A
Surface Area Compliance: N/A

This item is satisfactory - no work required -

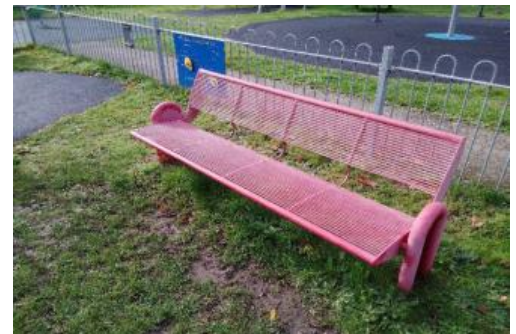
Item: Bench
Manufacturer: Owner/Operator
Surface Type: N/A
Item Quantity: 1
Equipment Compliance: N/A
Surface Area Compliance: N/A

This item is satisfactory - no work required -

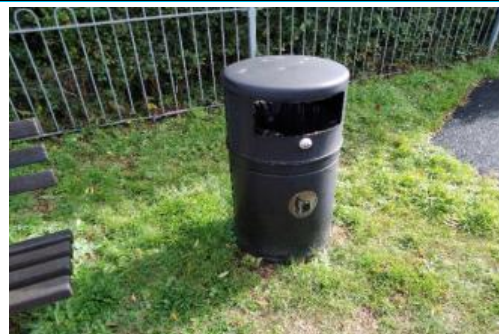
Item: Litter Bin
Manufacturer: Owner/Operator
Surface Type: N/A
Item Quantity: 1
Equipment Compliance: N/A
Surface Area Compliance: N/A

This item is satisfactory - no work required -

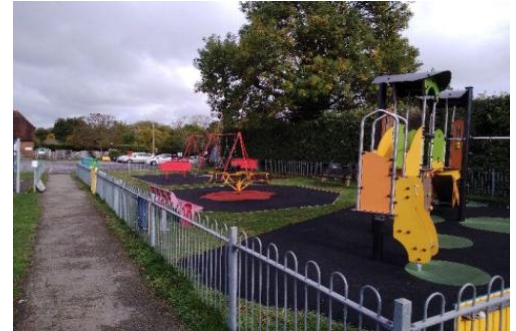
Item: Site General
Manufacturer: Owner/Operator
Surface Type: N/A
Item Quantity: 1
Equipment Compliance: N/A
Surface Area Compliance: N/A

The site is accessible to the public during the COVID 19 pandemic. The government have released guidelines for safely re-opening these types of facilities which is available on the government website. - Ensure there is an appropriate risk assessment in place and review regularly

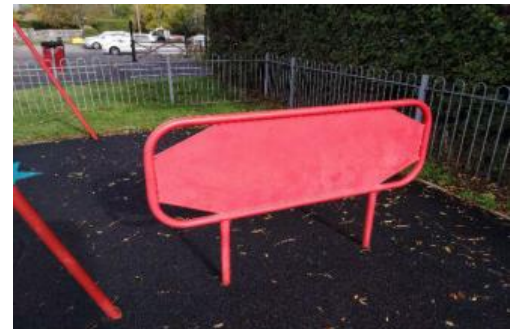
Item: Swing Barrier
Manufacturer: Owner/Operator
Surface Type: Wet Pour
Item Quantity: 2
Equipment Compliance: N/A
Surface Area Compliance: N/A

This item is satisfactory - no work required -

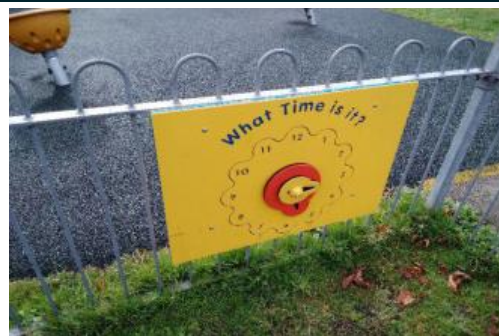
Item: Play Panel
Manufacturer: Not Identified
Surface Type: N/A
Item Quantity: 1
Equipment Compliance: Yes
Surface Area Compliance: N/A
Life Expectancy: >10 Years
Total Findings: 1

This item is satisfactory - no work required -

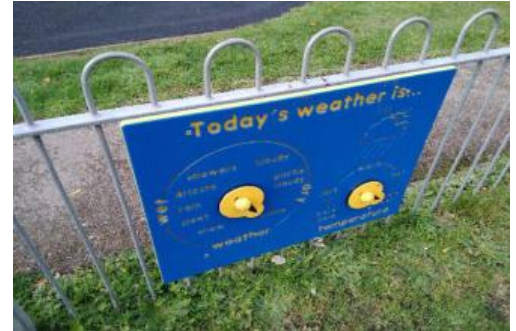
Item: Play Panel
Manufacturer: Not Identified
Surface Type: N/A
Item Quantity: 1
Equipment Compliance: Yes
Surface Area Compliance: N/A
Life Expectancy: >10 Years
Total Findings: 1

This item is satisfactory - no work required -

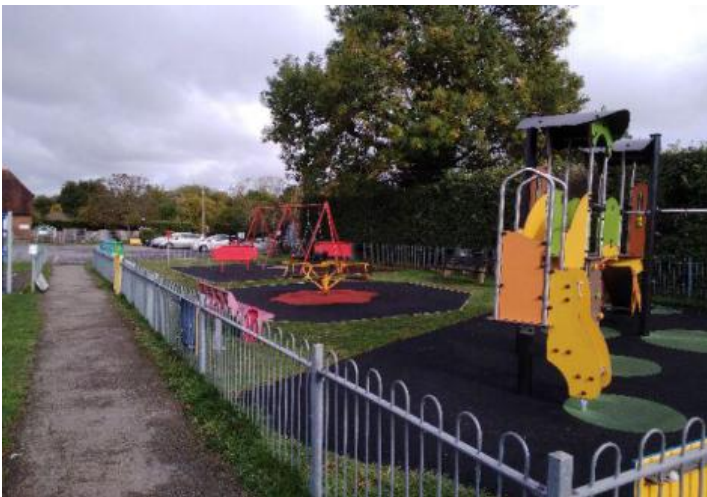
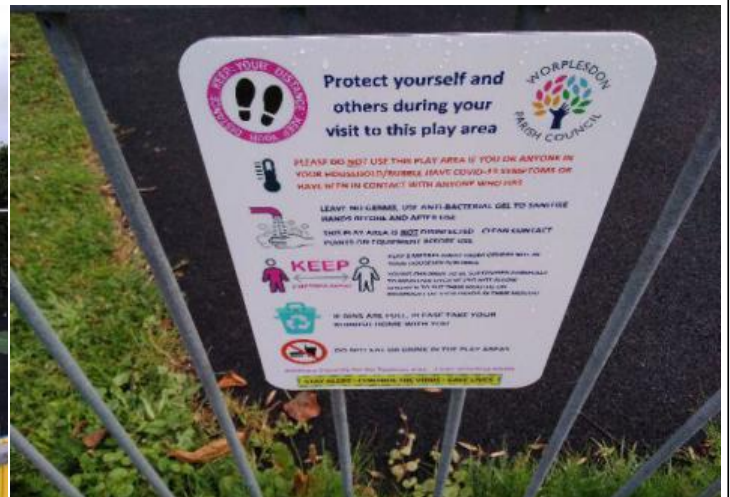
Item: Ancillary Items - Site General
Manufacturer: Owner/Operator

Finding: The site is accessible to the public during the COVID 19 pandemic. The government have released guidelines for safely re-opening these types of facilities which is available on the government website.

Action: Ensure there is an appropriate risk assessment in place and review regularly
